**PRELIMINARY ASSESSMENT/
VISUAL SITE INSPECTION**

**SUBURBAN SELF STORAGE FACILITY
(FORMERLY LIBERTY COPPER AND
WIRE COMPANY FACILITY)
DOWNERS GROVE, ILLINOIS
ILD 047 033 188**

FINAL REPORT

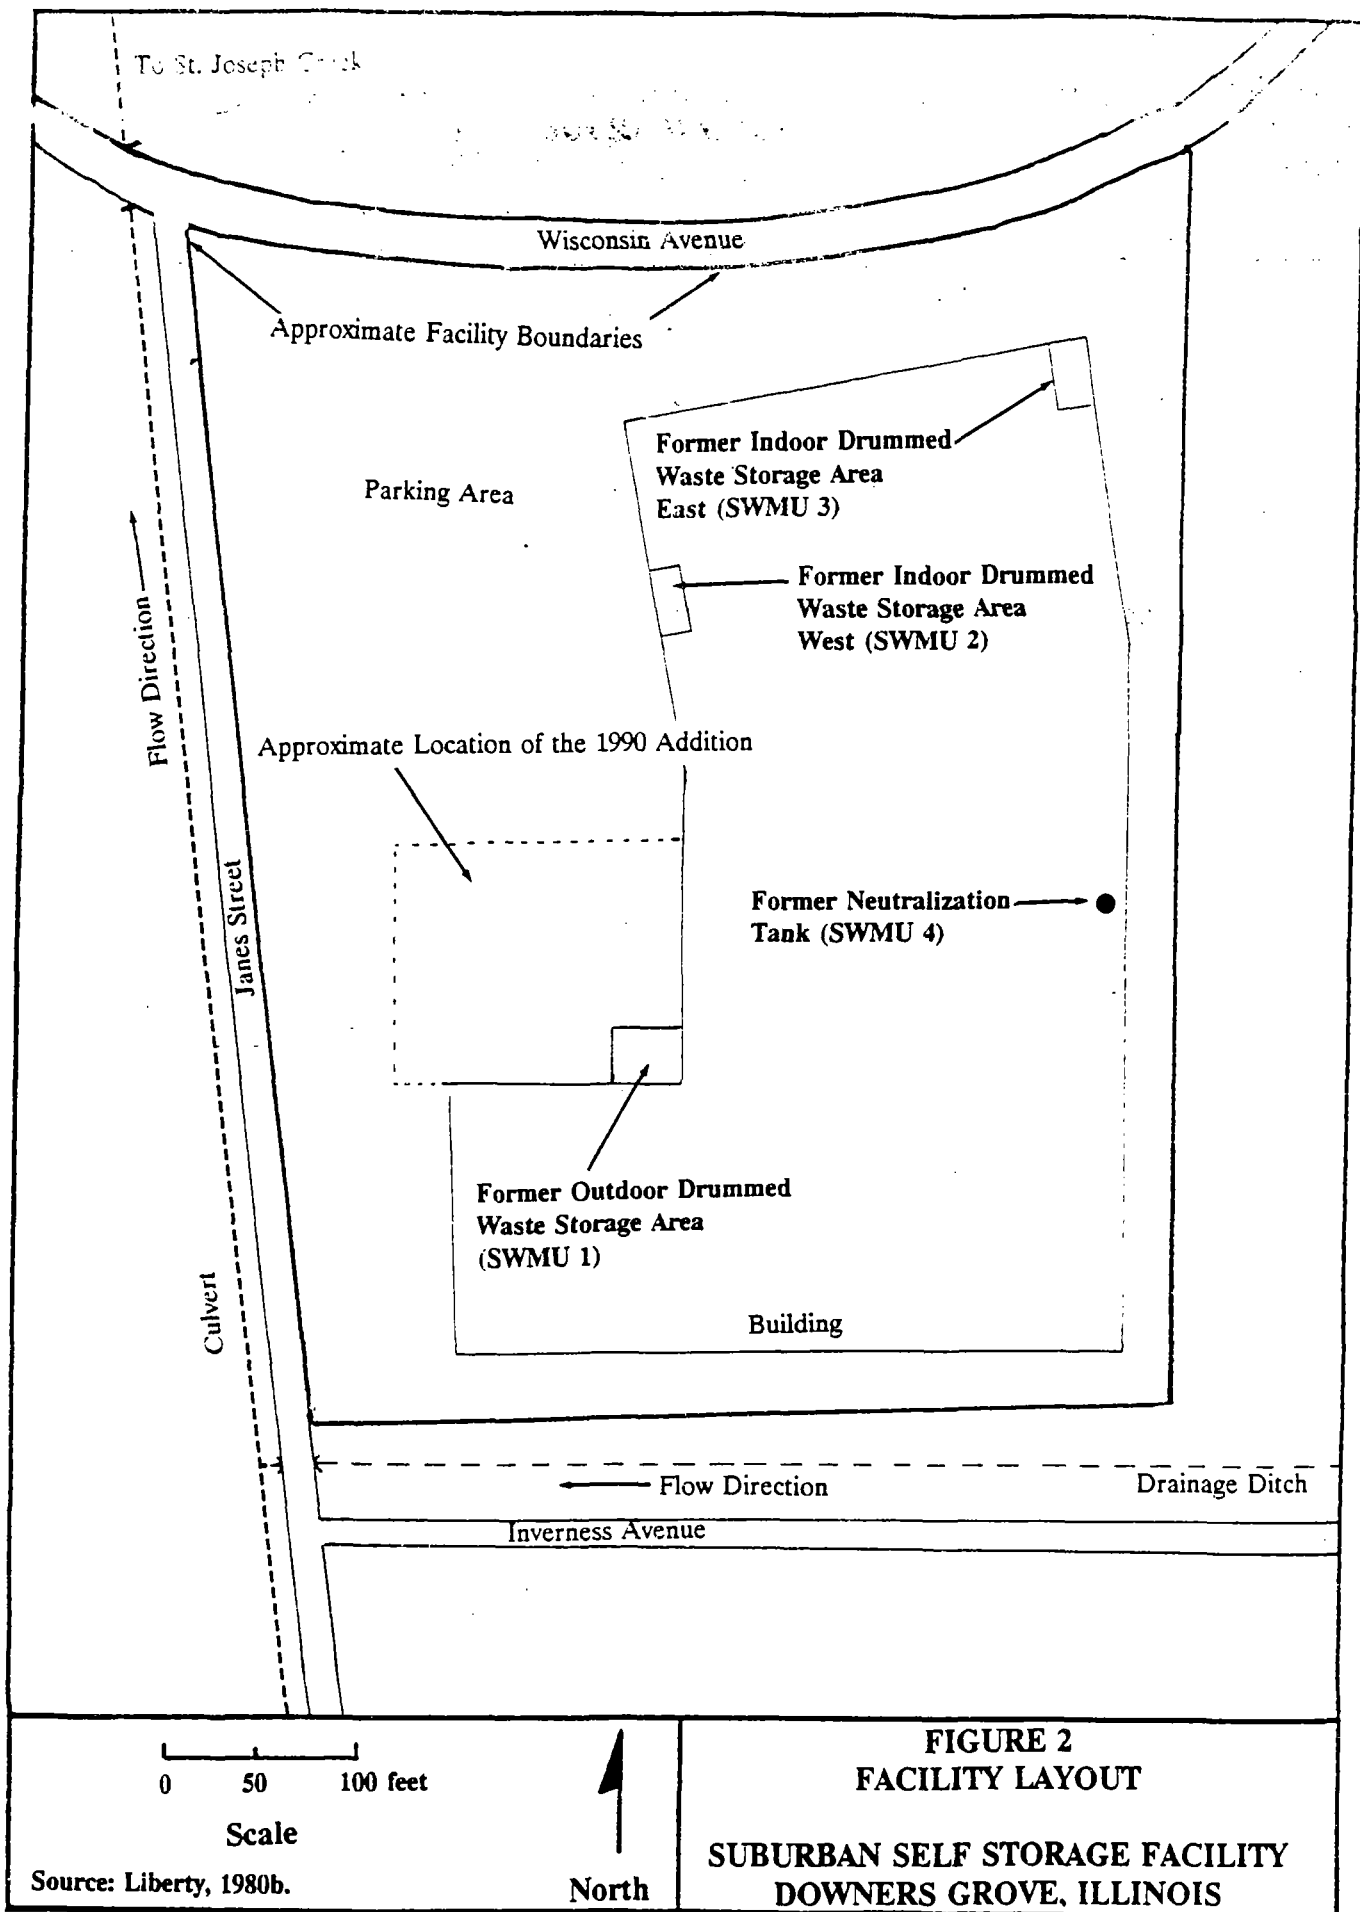
Prior to 1986, wastes were generated and managed at various locations at the facility. SWMUs and their current status are identified in Table 1. The locations of SWMUs in relation to the facility layout are shown in Figure 2. Wastes generated at the facility are summarized in Table 2. Facility generation and management of both hazardous and nonhazardous wastes, are discussed below.
